ASD-TR-77-77

A-10 WINDSHIELD SPALL TESTS

TECHNICAL REPORT ASD-TR-77-77  
FINAL REPORT FOR PERIOD SEPTEMBER 1973-FEBRUARY 1978

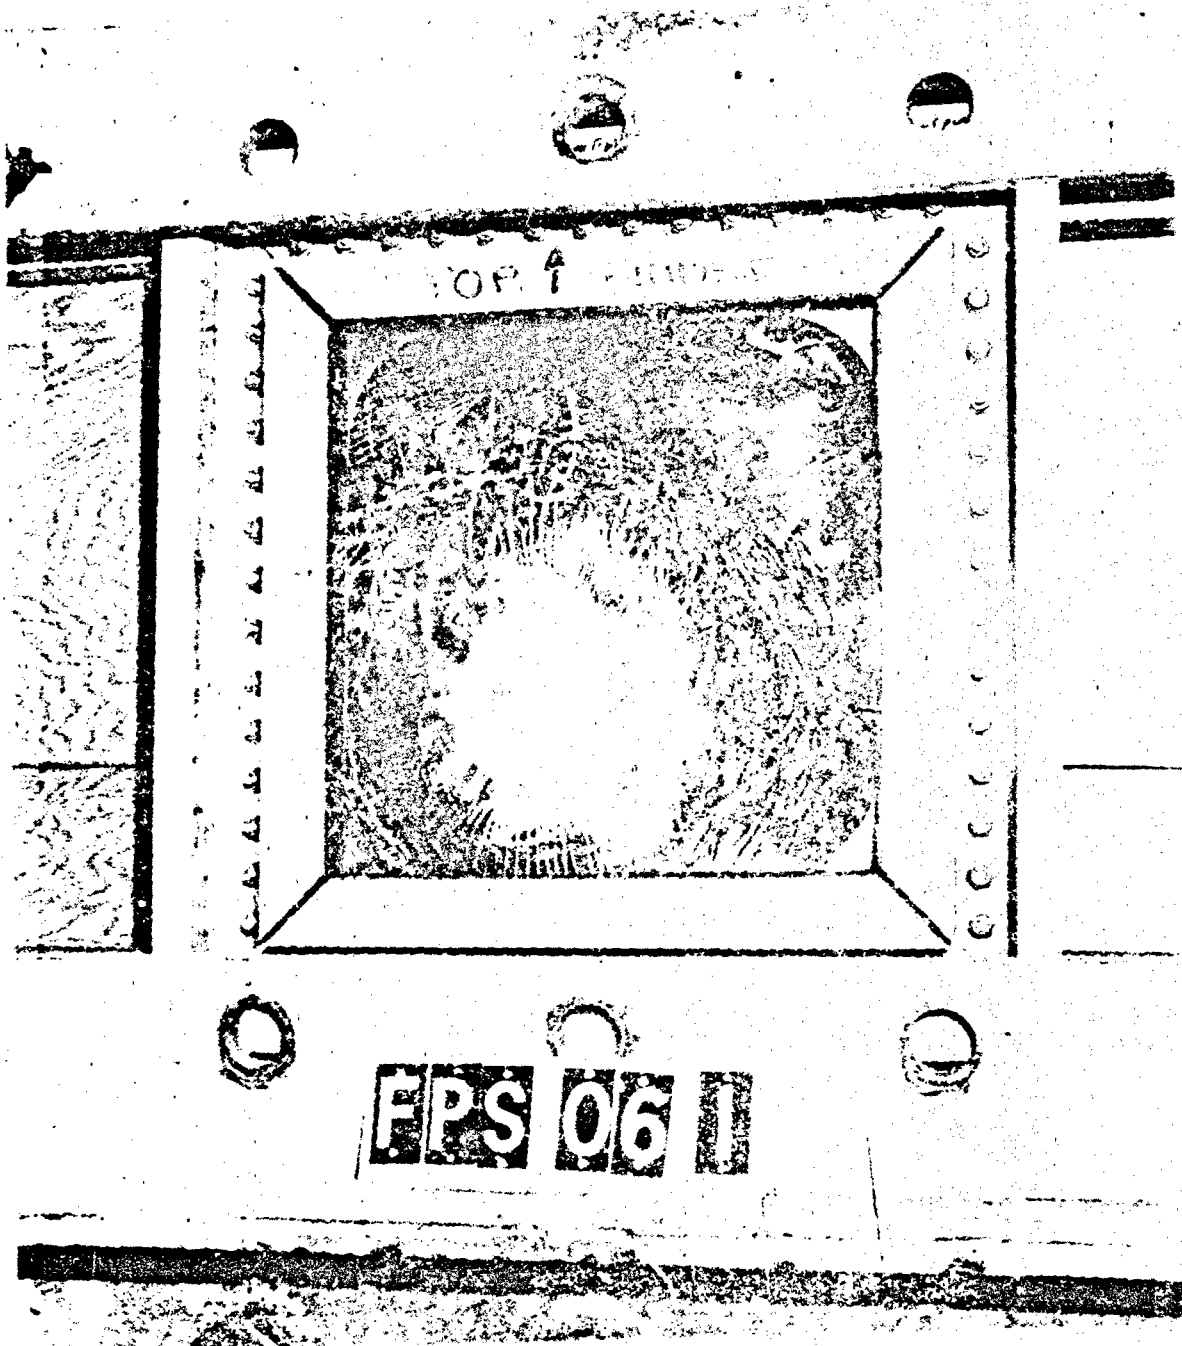
Figure 20. Poststrike Condition of Specimen FPS-06  
Shot No. 6, Type 1 Specimen

6 (FPS-06)	2147	None	3-1/4" x 2-1/2"	Good outside of impact area	Cracks emanate radially from A 3-1/2" crater containing the impact point at its center. These cracks terminate at a concentric crack.

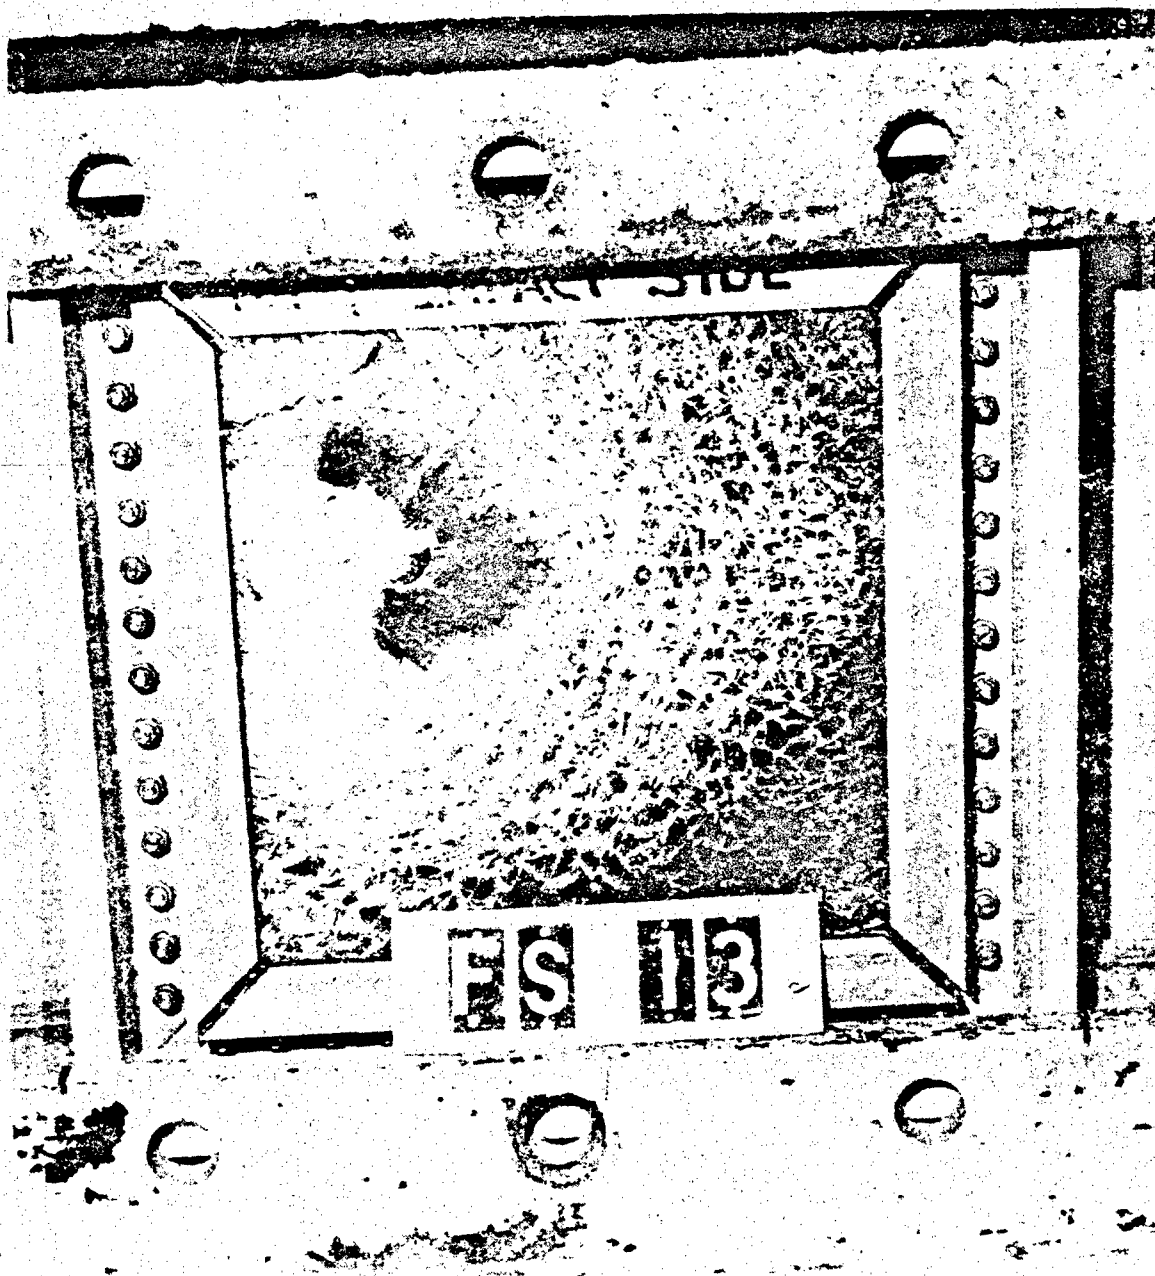
Figure 21. Poststrike Condition of Specimen FS-13  
Shot No. 1, Type 2 Specimen

Panel Specimen Number	Average Projectile Velocity (fps)	Penetration of Specimen	Impact Crater	Visibility	Crack Pattern	Comments
1 (FPS-13)	2294	1st PVB layer & 1st two glass layers		Completely Obscured		Projectile ricocheted off
2 (FPS-14)	2169	1st PVB layer & 1st two glass layers		Entire specimen obscured by cracks	Cracks throughout	
3 (FPS-15)	2444	1st PVB layer & 1st two glass layers		Vision through approximately 1/4 of glass panel	No cracks in backface layer	
4 (FPS-16)	2518	1st PVB layer & 1st two glass layers		Almost completely obscured	Radial light cracks in backface layer	
5 (FPS-17)	2122 *	Complete. Aluminum witness sheet destroyed. Some backface spall. Wall board behind had 8 complete penetrations & numerous partial penetrations	elliptical: 4" x 2-1/4"	Completely obscured		i) Second PVB layer slashed open. ii) Second 3/8" glass layer had 6" x 3-3/4" spall piece. iii) Third PVB layer came off in pieces & a large PVB petal formed at bottom of elliptical hole. iv) Last glass layer had same elliptical hole pattern.

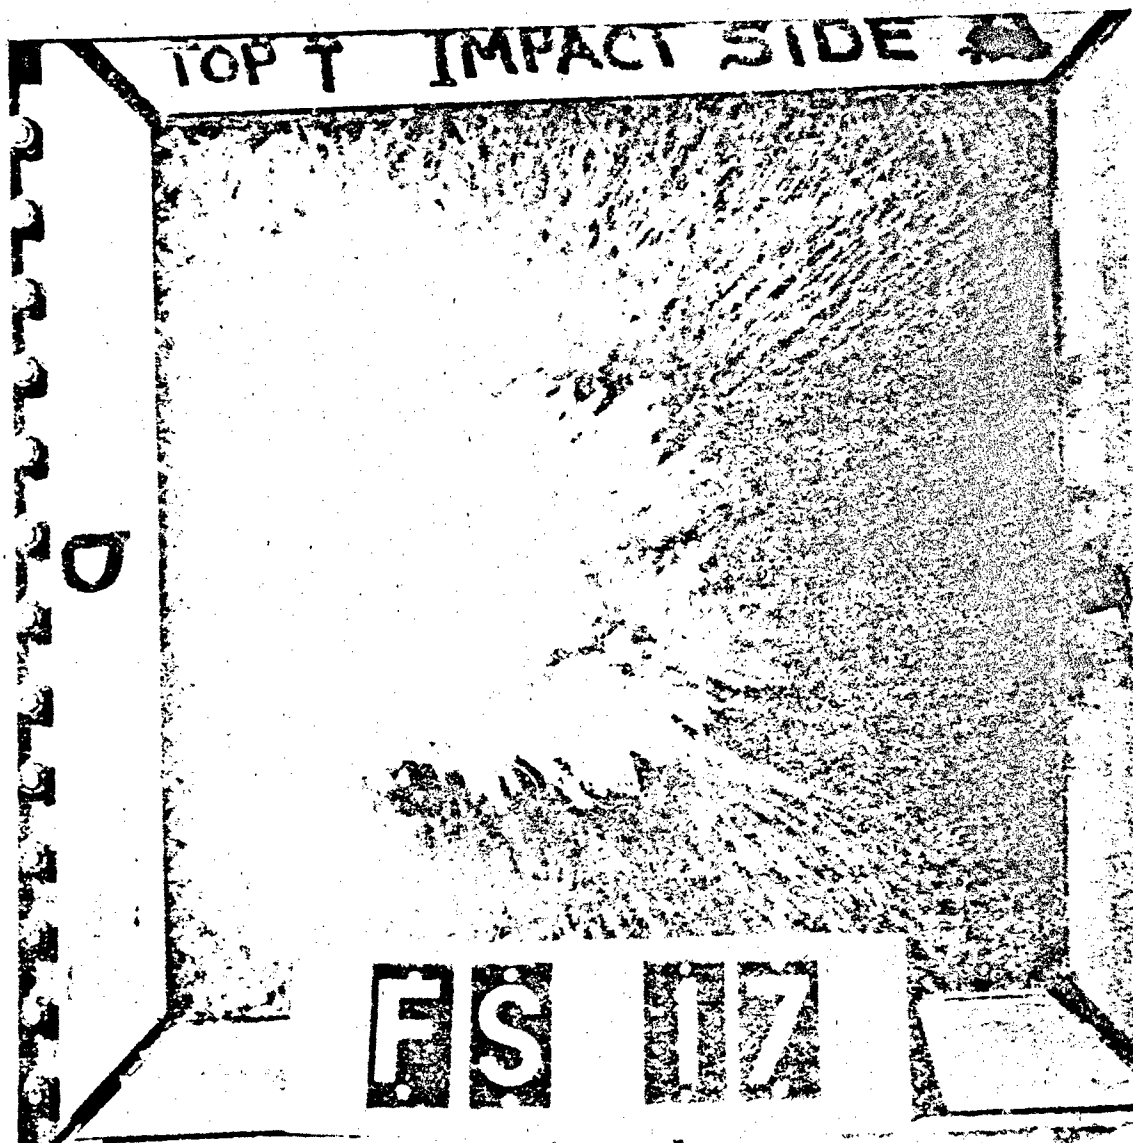
Figure 24. Poststrike Condition of Specimen FS-17  
Shot No. 5, Type 2 Specimen

The rationale for FS-17 was to impact it with a 12.7-mm projectile at the same velocity as the 7.62-mm projectiles fired earlier. Having a common velocity, the relative difference in damage effects could be narrowed down to differences in projectile mass. Should a complete penetration occur, the last specimen (FS-18) would be impacted at a much lower velocity and the damage effects assessed. These last two tests were purely qualitative with no attempt made to determine the ballistic  $V_{50}$  of the panels using the standard "up-and-down" velocity testing methodology used in armor ballistic acceptance testing.
